## Thermographic Exception Report

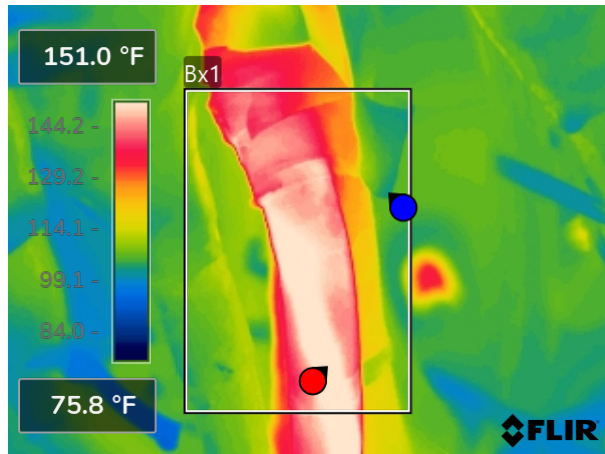
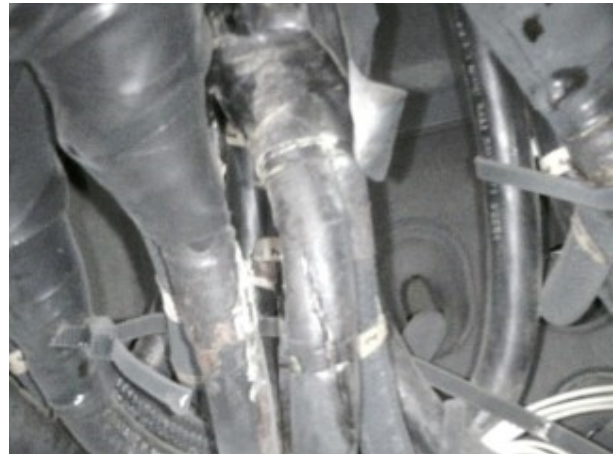
Area/Item I.D.	CC196/Engine Room #4
Description	Junction Box Recip 2
Severity Assesment	Level-4 Critical
Detail	One of motor wiring insulation severally damaged and exposed bare wires.
Action Recommended	Schedule motor repair.

Measurements	
<b>Bx1</b>	
Max	189.5 °F
Avg	126.1 °F
Min	104.6 °F
