Plant Name/Location	XXXXXXXXXX
Date	16-Jul-12
NDT Instrument/Operator	Pitting gauge/Hank Noguchi
Inspection ID#	Condenser #1 model PMCB 850
Manufacturer	Evapco

Plant Name/Location	xxxxxxxxxx
Date	16-Jul-12
NDT Instrument/Operator	Pitting gauge/Hank Noguchi
Inspection ID#	Condenser #3 model PMCB 480
Manufacturer	Evapco

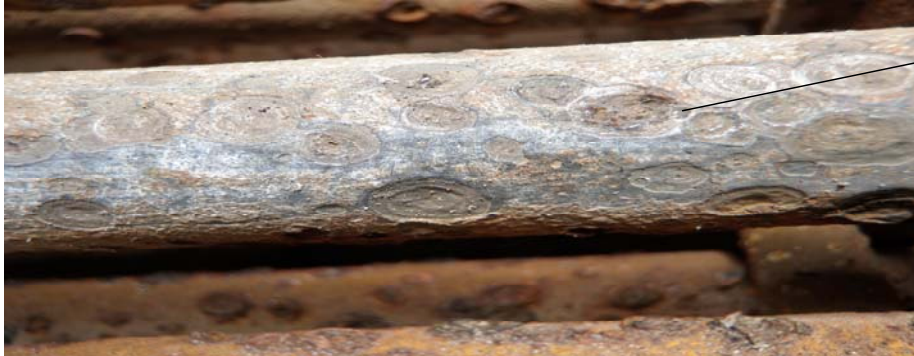
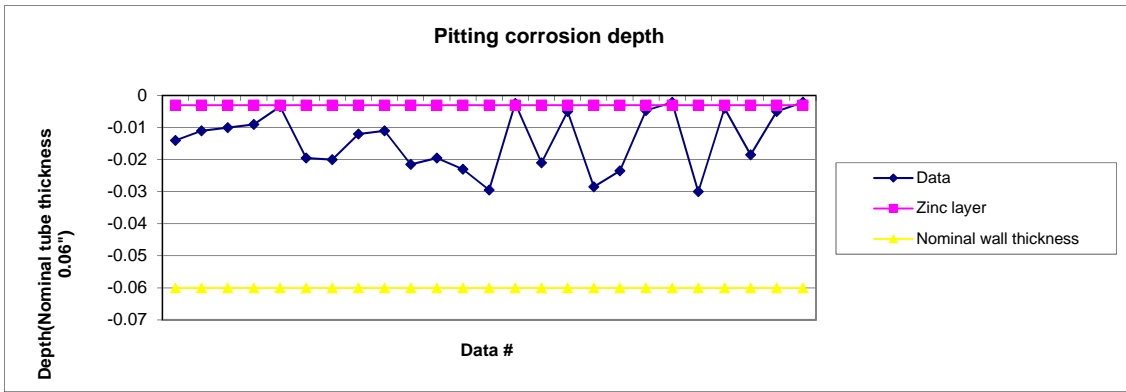
Pitting depth is measured by using pitting gauge at 25 point and calculate statistical data.

3. Testing Material Data		4. Measurement Data	
Material	Steel	Maximum wall thickness	(inch) 0.03
Piping material grade	N/A	Minimum wall thickness	(inch) 0.0579
Nominal size	1.05 Inch	Median wall thickness	(inch) 0.048
		Mean wall thickness	(inch) 0.046
Nominal piping wall thickness	0.06 inch		
Construction	Weld		
Media	NH3/Oil		
Operating pressure	300 psig		
Relief valve pressure	300 psig		
Operating temperature	250 F		
Years of service(Estimate)	4 years

5. Evaluation	
Corrosion rate in MPY(Mills Per Year)	7.5
Theoretical piping wall left for service	0.018 Note: Mini measured wall thickness - Required mini.wall thickness(normally 20%)
Estimated Remaining piping life left	2.4 years

Comment
 Heavy pitting observed
 Protective zinc coating was severely damaged.
 Only 2.4 years of service left

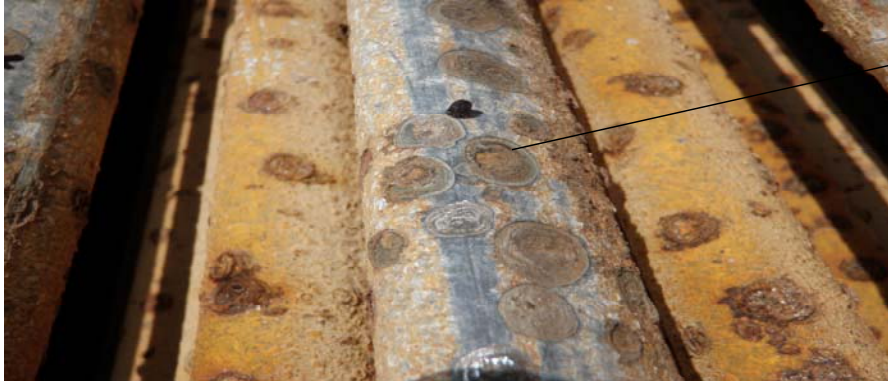
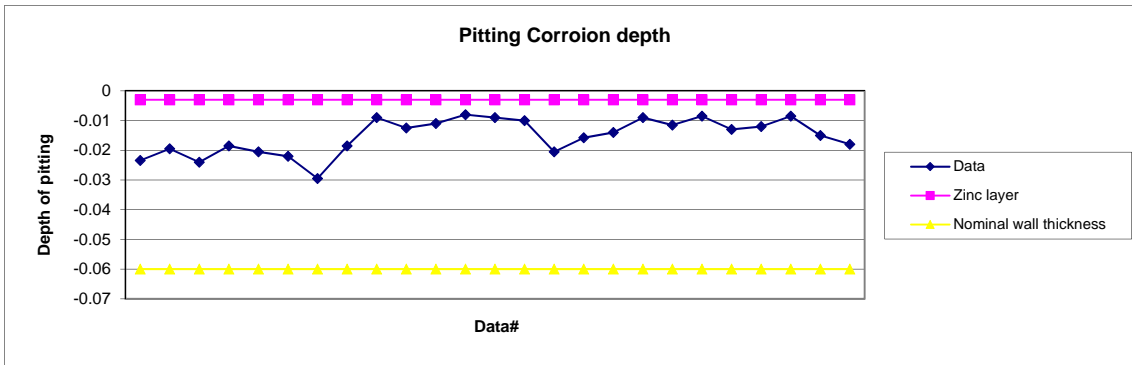
Pitting depth is measured by using pitting gauge at 25 point and calculate statistical data.

3. Testing Material Data		4. Measurement Data	
Material	Steel	Maximum wall thickness	(inch) 0.0305
Piping material grade	N/A	Minimum wall thickness	(inch) 0.053
Nominal size	1.05 Inch	Median wall thickness	(inch) 0.046
Nominal piping wall thickness	0.06 inch	Mean wall thickness	(inch) 0.045
Construction	Weld		
Media	NH3/Oil		
Operating pressure	300 psig		
Relief valve pressure	300 psig		
Operating temperature	250 F		
Years of service(Estimate)	4 years

Corrosion rate in MPY(Mills Per Year)	7.375
Theoretical piping wall left for service	0.018 Note: Mini measured wall thickness - Required mini.wall thickness(normally 20%)
Estimated Remaining piping life left	2.440677966 years

Comment
 Heavy pitting observed
 Protective zinc coating was severely damaged.
 Only 2.4 years of service left
