PdM Solutions of San Antonio, Inc

Vibration Analysis Summary

Plant Name	Sanderson Farm Easterly Feed Mill plant
Location	Franklin, TX
Date	July 9, 2024

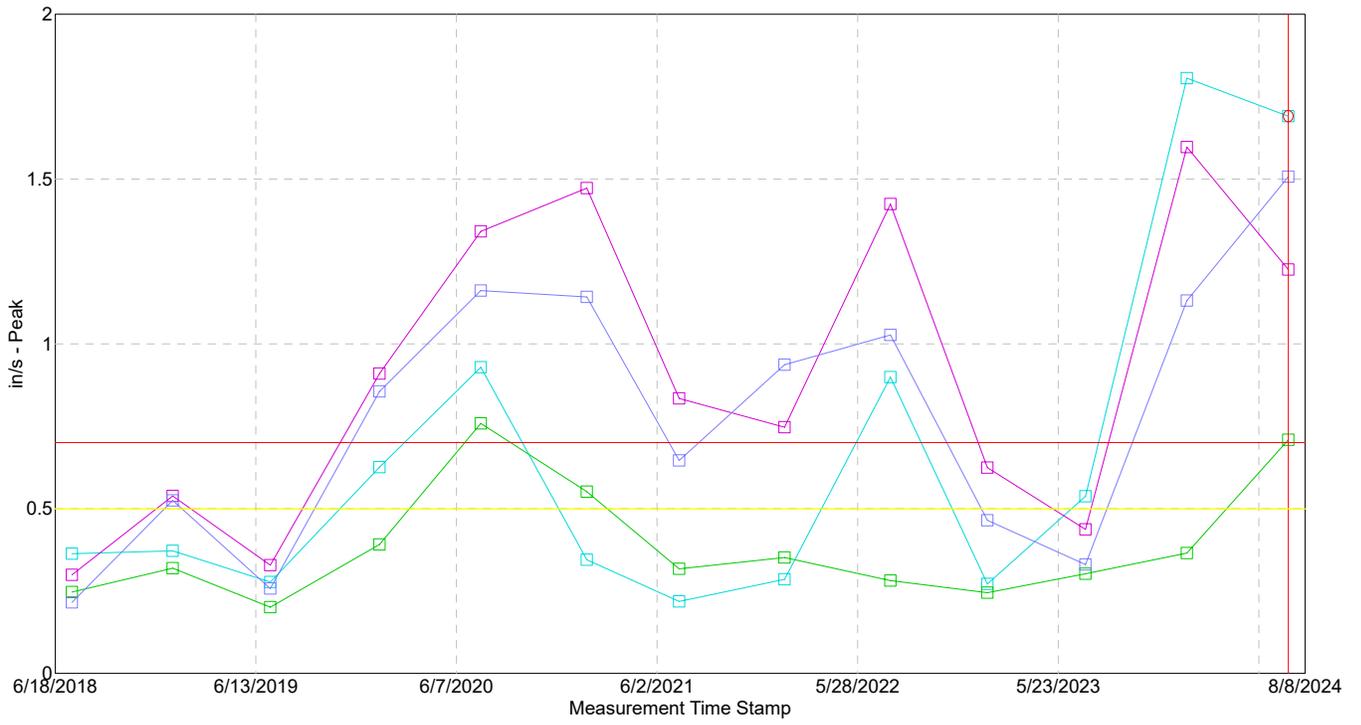
Trend
#2 Hammer Mill 4 \ COMP NDE-H VEL, Channel X
#2 Hammer Mill 4 \ COMP NDE-H VEL, Amp: 1.69, Date/Time: 7/9/2024 3:45:54 PM

Comment
Hammer Mill		Mill and motor vibration continued and remained mostly unchanged. Data shows looseness, balancing and/or coupling damages.
Motor		
Alignment

- Tighten all bolts/nuts and anchoring.
- Check coupling for damages such as twisted or shredded center piece.
- Check balancing of mill cages and blades.

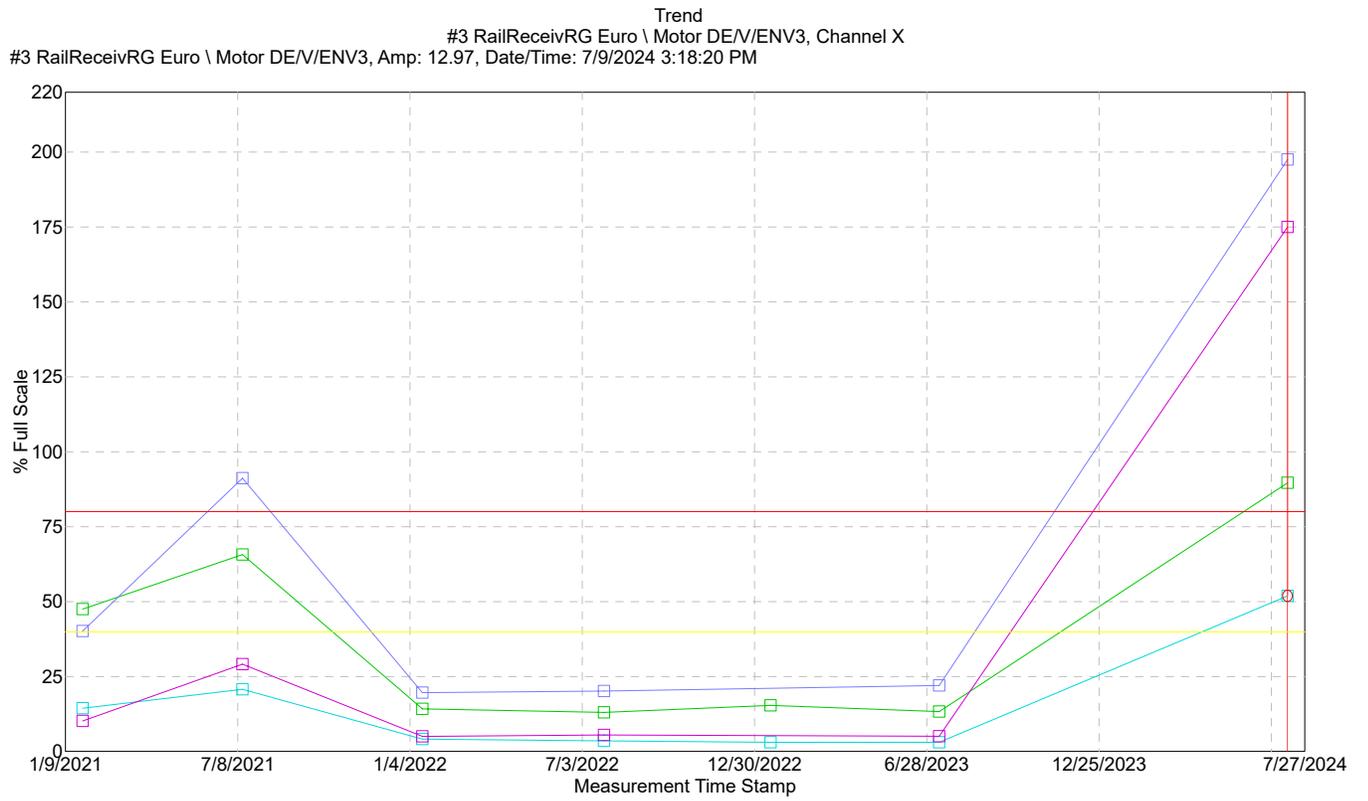
Comment
Gear Box		
Motor		High motor/drive-end bearing vibration observed. Data shows signs of bearing wear as well as looseness/balancing.
Pillow Block Bearings

- High motor vibration observed. Data shows signs of mechanical looseness/unbalancing problems.
- Very high motor bearing vibration observed on drive-end side of motor. Data shows signs of bearing wear.

- Tighten all bolts/nuts on the motor and all supports/anchoring.
- Check motor coupling for any signs of damage.
- Grease up bearings.
- Prepare for motor bearing change out.
