Vibration Analysis Summary

Plant Name	Sanderson Farm
Location	Oakwood, TX
Date	July 9, 2024

Vibration Analysis Cover Sheet

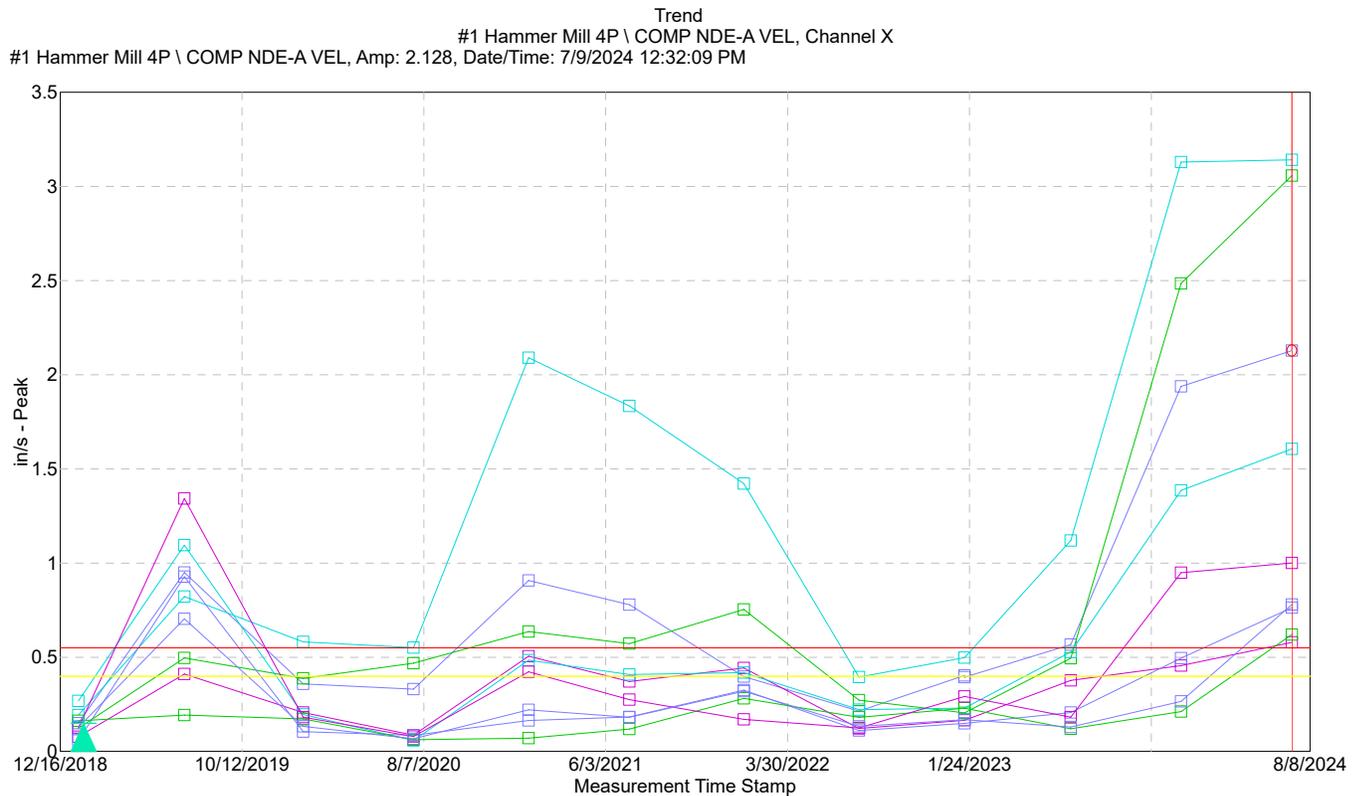
- High hammer mill and motor vibration continued and trending higher.
- Data shows signs of balancing and mechanical looseness. Check for loose pillow block bolts and/or damage to the frame structure or bearing pedestal.
- Such high vibration can cause damage to outboard bearings on the mill.

Vibration trend data
#1 Hammer Mill and motor vibration continue trending higher. Data showed looseness and/or balancing of rotor/hammers. Check balancing of rotor cage and check hammers.(shape and qty of hammers on the shaft)
Check alignment of the motor and damages on coupling. Tighten all anchoring bolts/nuts.

- This H/M is not safe to operate. It will cause serious damages on motor and H/M.
- Immediately tighten all anchoring/nuts/bolts.
- Check/adjust alignment and coupling for damages such as shredding/twisting center piece.
- Check outboard pillow block bearings housing for looseness.
- Check balancing of mill rotor and make sure of the same qty of blades are on each rod.

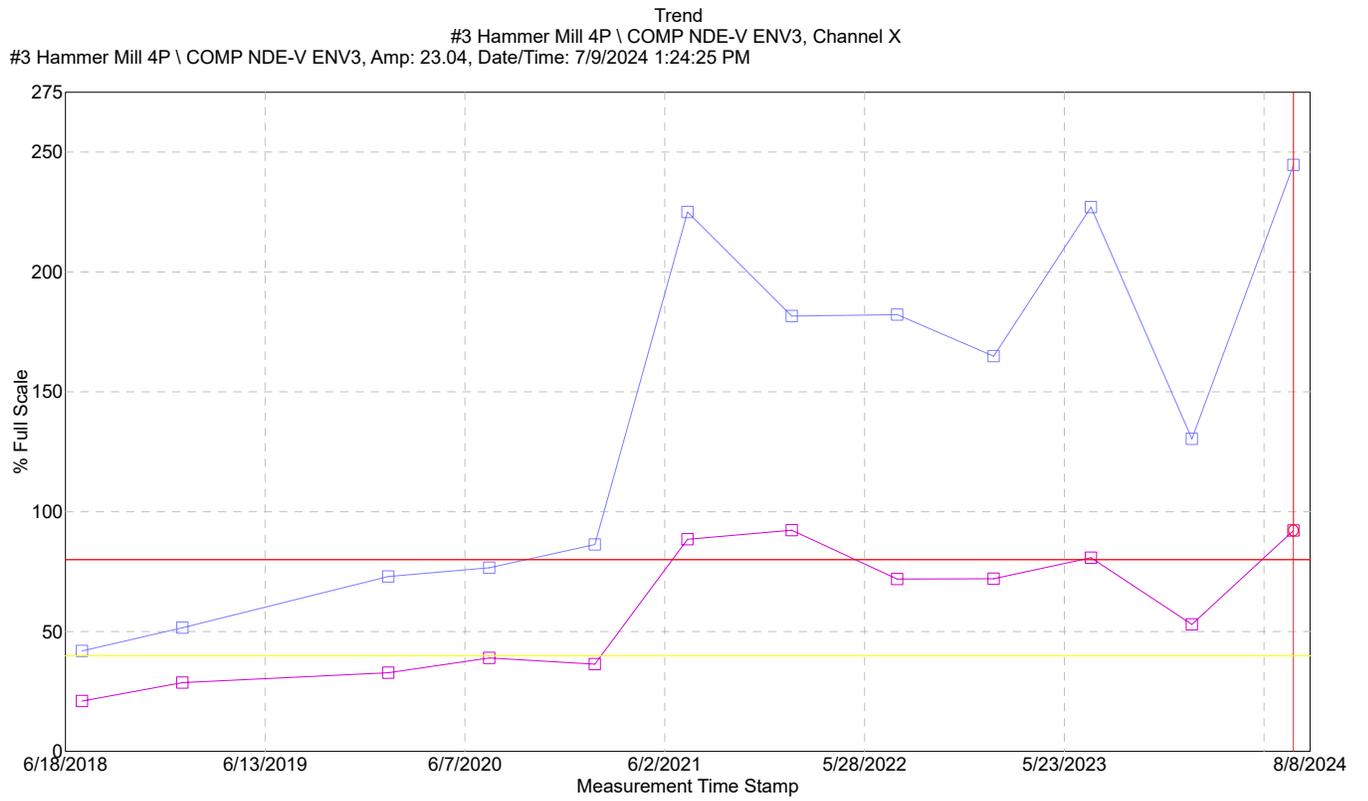
- High hammer mill vibration continued and increasing on non-drive end side of mill to non-reliable levels.
- Higher mill's drive end bearing noise is continued at critical levels.
- Hammer mills drive end bearings are not reliable for continuous operation.
- Mill bearings show signs of lack of lubrication.

- Schedule mills bearings change out.
- Check and clean off motor fan blades.
- Tighten all anchoring/nuts/bolts.
- Check coupling for damages center piece such as twisted or shredded.

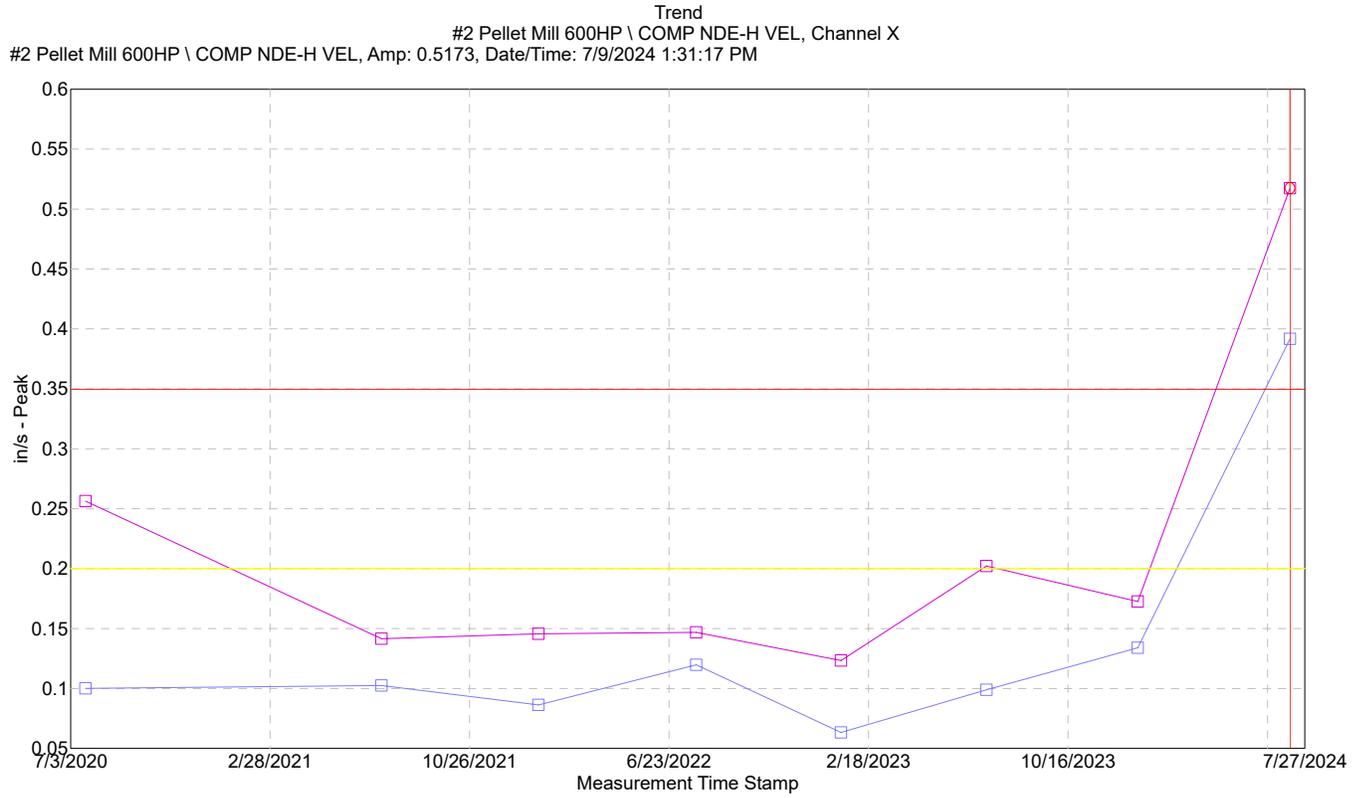
- Pellet mill vibration has increases in horizontal direction.
- Data shows signs of looseness.

- Tighten all bolts/anchoring to proper torque.
- Check vibration in 6 months.

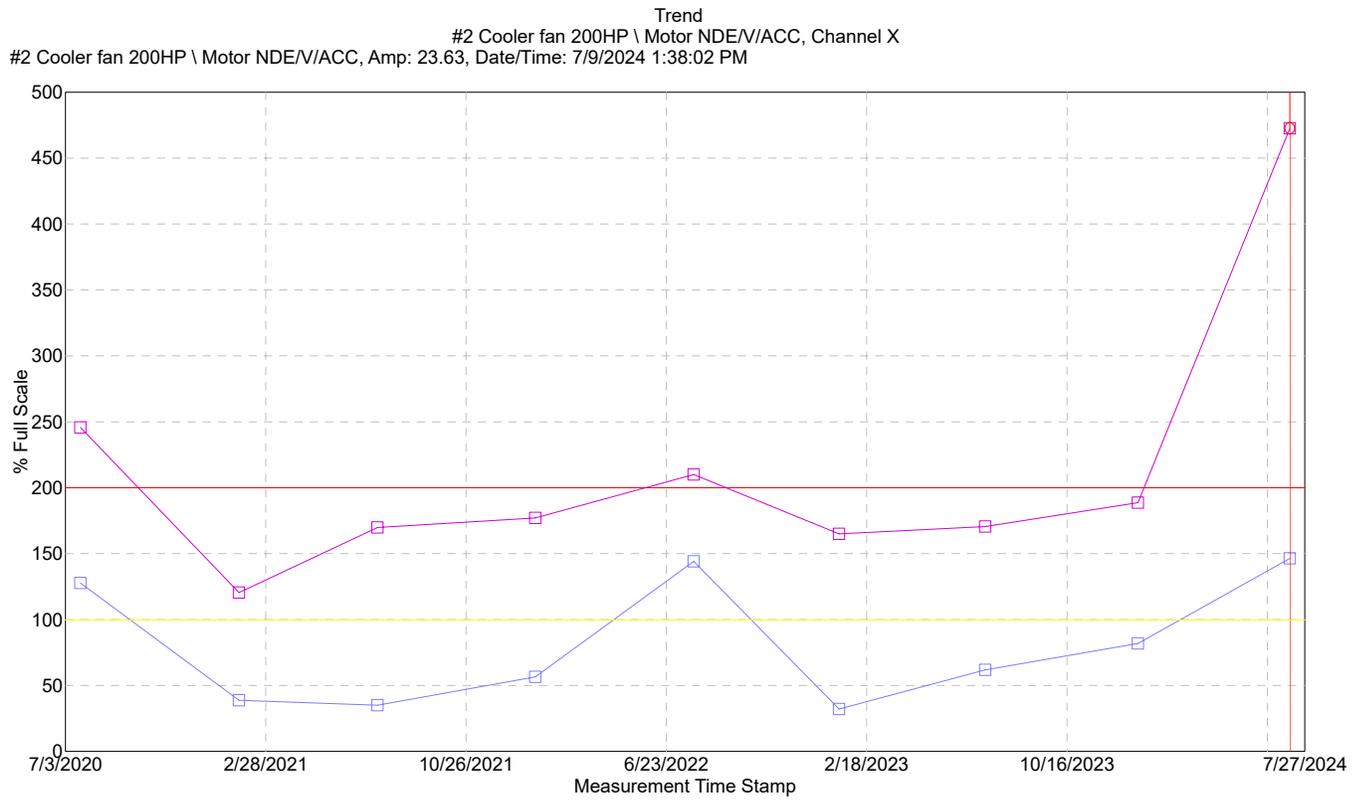
- High motor's drive end bearing noise continued.
- High motor's non- drive end bearing noised continued and increasing to critical level.
- Vibration continued to show signs of lack of lubrication.

- Grease up motor bearings recommended amount.
- Prepare to change out motor.
