PdM Solutions of San Antonio, Inc

Vibration Analysis Summary

Plant Name	Sanderson Farm Easterly Feed Mill plant
Location	Franklin, TX
Date	July 15, 2025

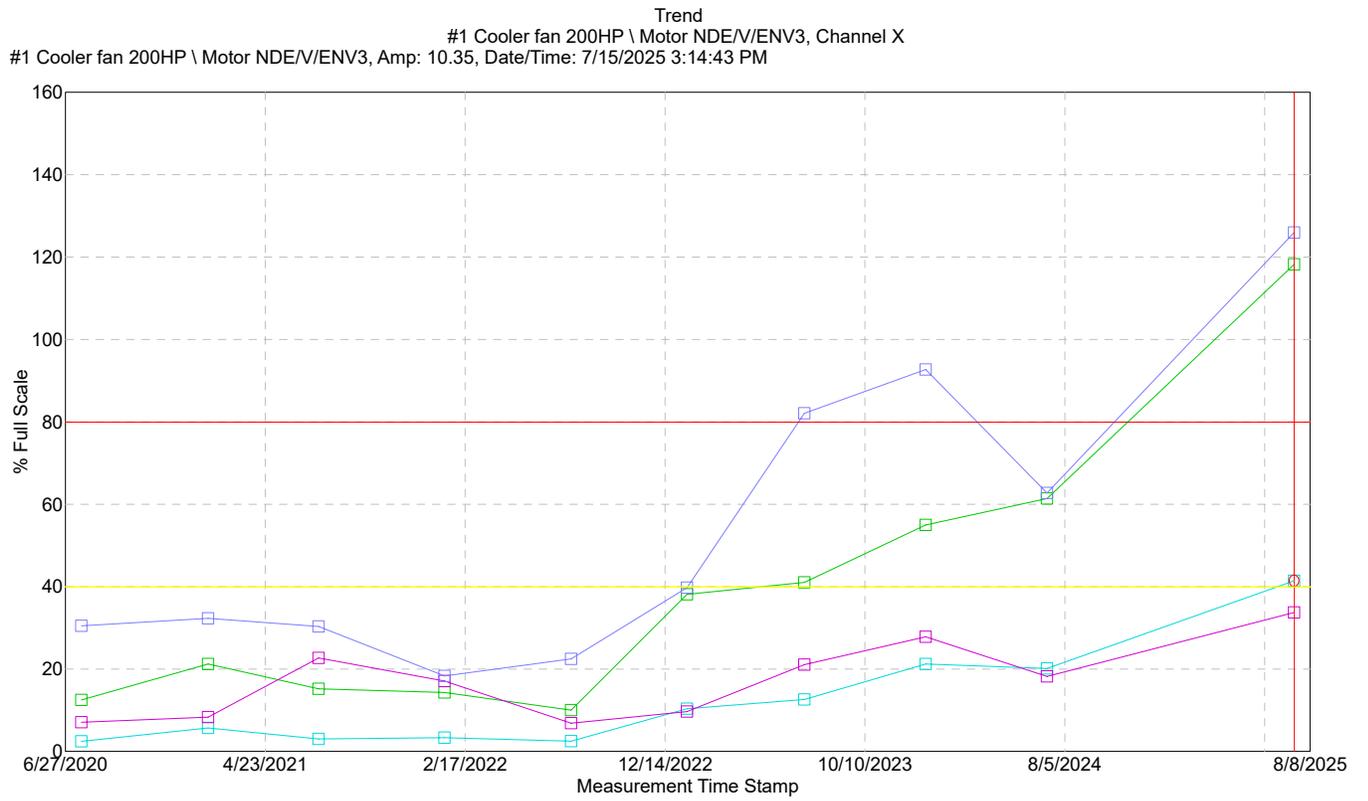
Comment
Fan		
Motor		Higher motor bearing noise continued. Data continued to show defects on bearings raceways and/or ball/roller.
Pillow Block Bearings

- Grease up the motor bearings
- Carefully monitor the motor bearings for sudden bearings condition changes such as louder noise and higher bearing temperature.

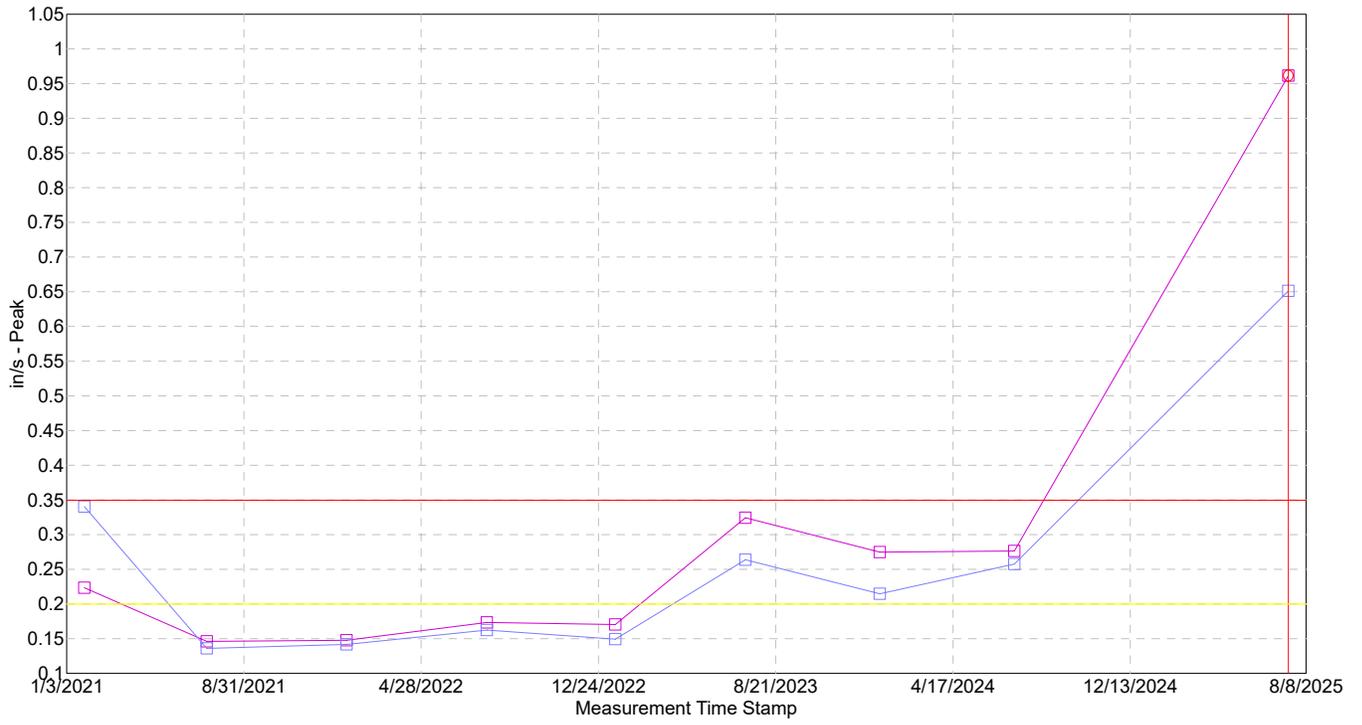
Trend
#2 Cooler Fan 200HP \ Motor NDE/H/VEL, Channel X
#2 Cooler Fan 200HP \ Motor NDE/H/VEL, Amp: 0.9614, Date/Time: 7/15/2025 3:17:54 PM

#2 Cooler Fan	Industrial Air Tech 445		Motor vibration jumped. Data showed signs of looseness/unbalancing. Check vibration isolation absorber for loose items such as bolts/nuts/springs. Tighten all anchoring/nuts/bolts.
	Motor Baldor 200HP/4P

Comment
Fan		
Motor		Motor vibration jumped. Data showed signs of looseness/unbalancing.
Pillow Block		
Bearings

- Check vibration absorber underneath the unit for looseness/damages such as loose bolts/nuts and/or cracked springs.
- Tighten all bolts/nuts/anchoring.
