PdM Solutions of San Antonio, Inc

THERMOGRAPHIC REPORT

Date:	8-20-2001	Contract #:	XXXXXXXX
COMPANY NAME:	XXXX	LOCATION:	San Antonio, Texas
ADDRESS:	XXXX	EQUIPMENT ID:	C3-Starter Soft Starter
CITY, STATE ZIP:	XXXXX	SEVERITY:	PROBLEM

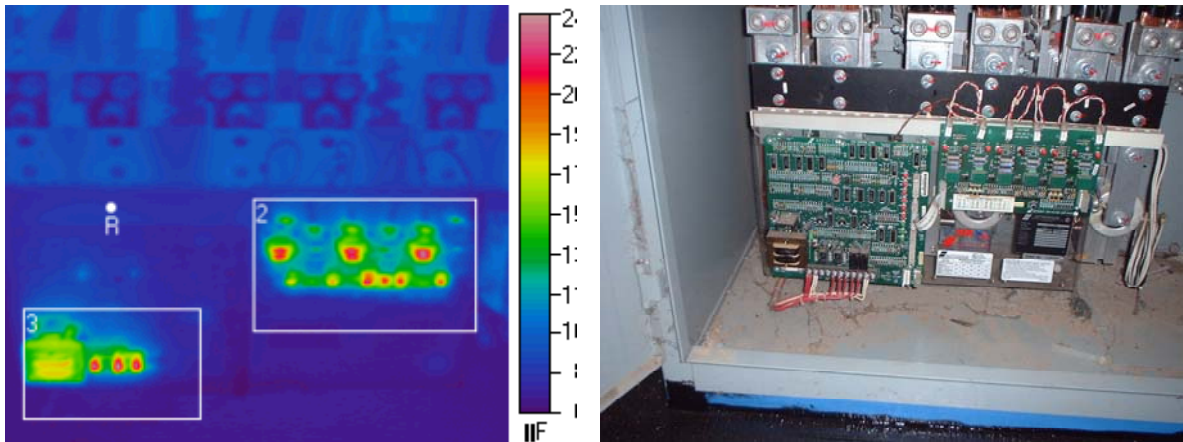
Ref.	Rect2	Rect3
Emiss.	0.970	0.970	0.970
Avg °F		110.7	105.9
Min °F		73.0	71.3
Max °F	86.1	243.7	251.2
Delta °F		158.7	166.1

PROBLEM:	Over heated starter control board
RECOMMENDATION:	Temporarily install cooling fans. Contact factory for permanent solution
INSPECTOR:	XXXXXXXX
ASSISTANT:	Non
CORRECTIVE ACTION TAKEN:	Will install cooling fans
